a guide for the
geologic and hydrologic evaluation
of small lake sites in missouri

Dean, Thomas J., James H. Barks and James H. Williams, 1976, A GUIDE FOR THE GEOLOGIC AND HYDROLOGIC EVALUATION OF SMALL LAKE SITES IN MISSOURI: Mo. Dept. of Natural Resources, Geological Survey, WR 31, 56 p., 24 figs., 2 app.

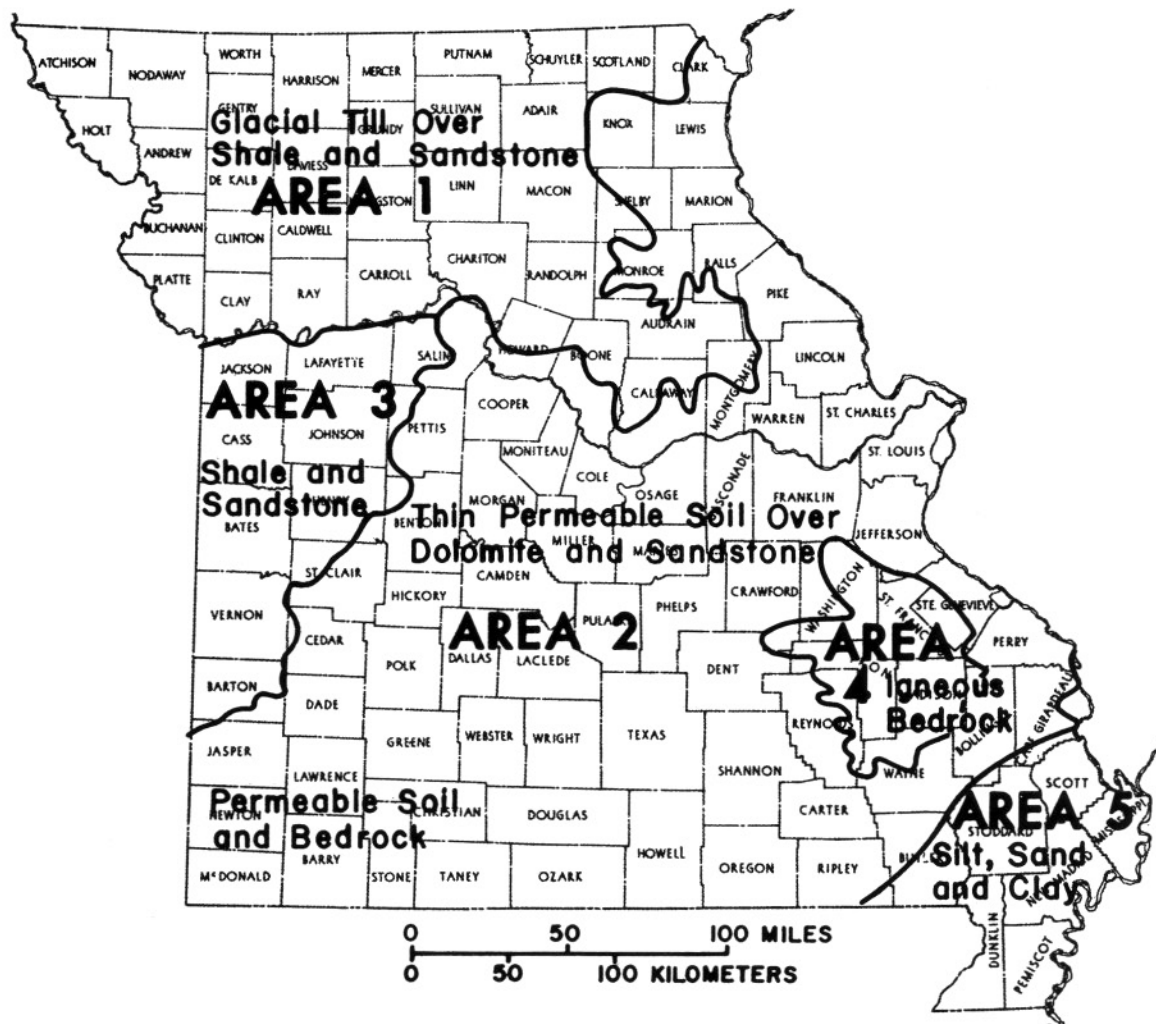
Figure 1

Generalized geologic map showing the five major geologic areas of Missouri.

As a first step in delineating typical lake settings in Missouri, the state was subdivided into five generalized areas as

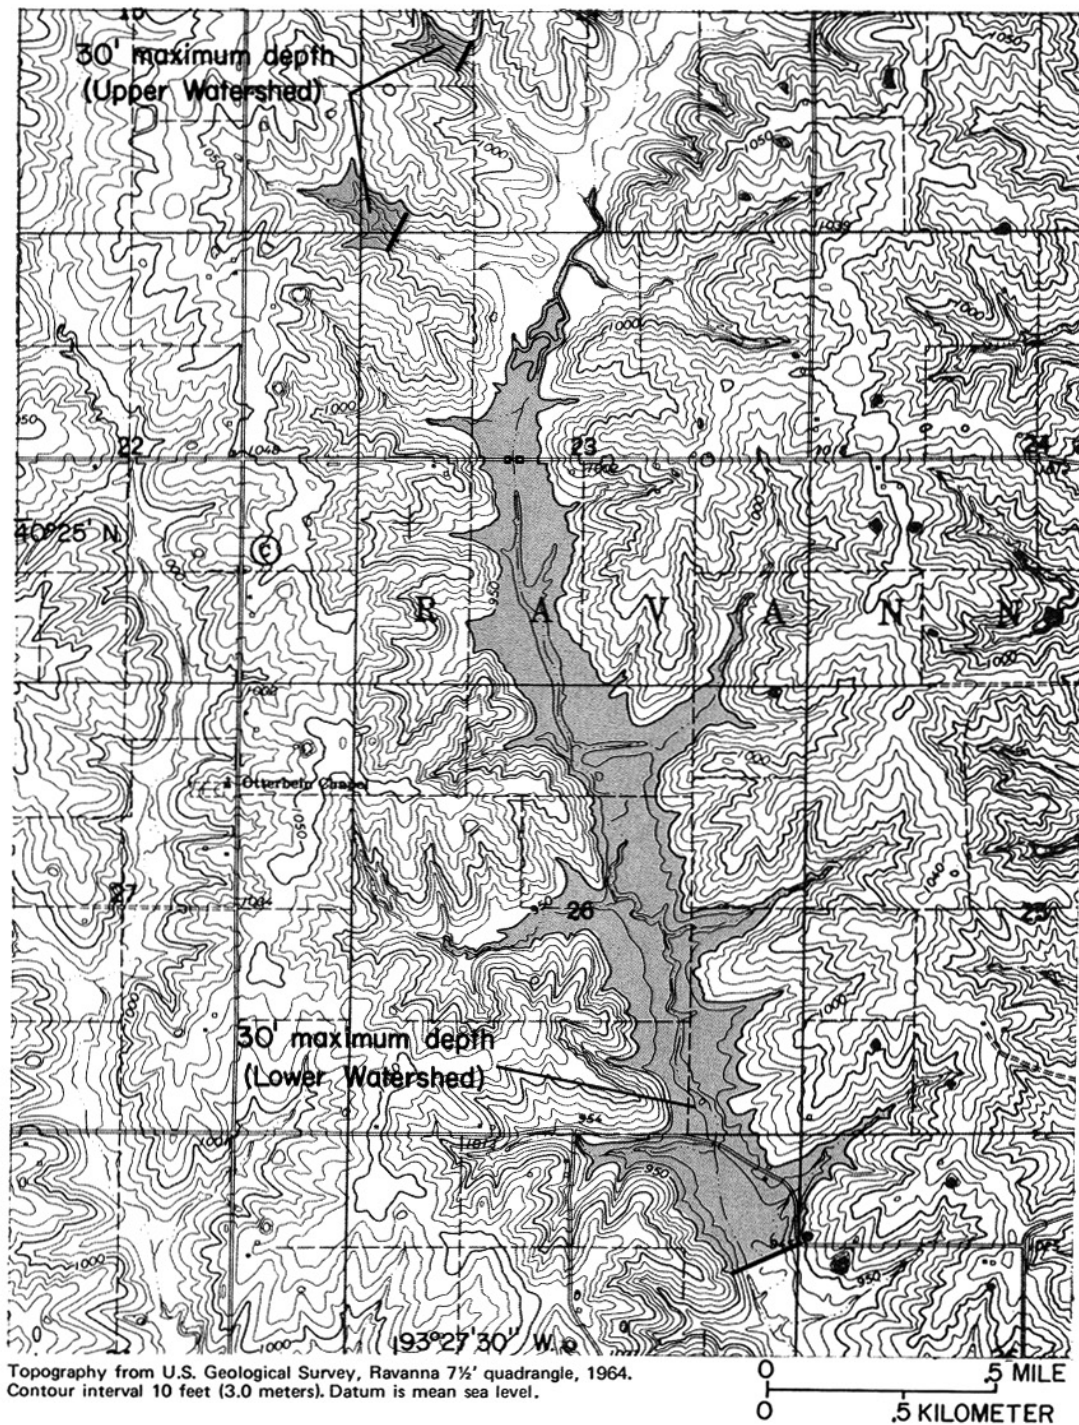
Figure 2

Topographic map showing hypothetical upper and lower watershed lakes in the glaciated area of northern Missouri.

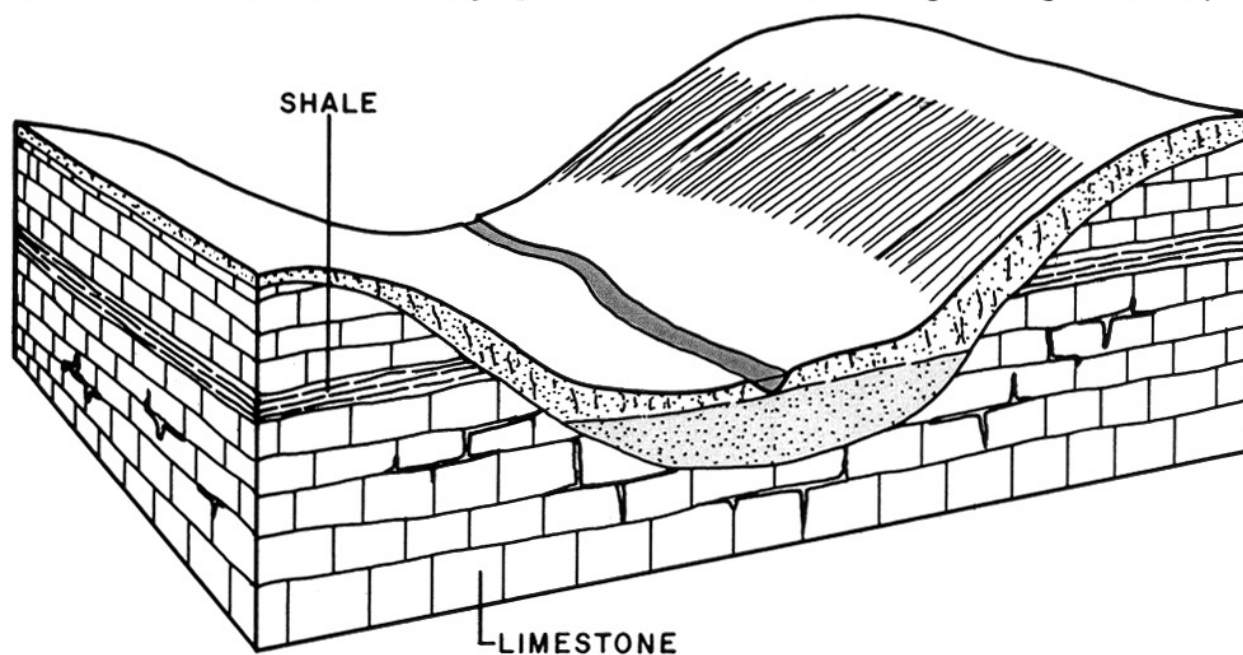
Schematic diagram of a valley cross section showing water loss through fractured or jointed limestone.

Shale or limestone bedrock is at or near the surface in some areas. Figure 3 shows how openings in fractured limestone are the major cause of leakage problems in the upper watersheds.

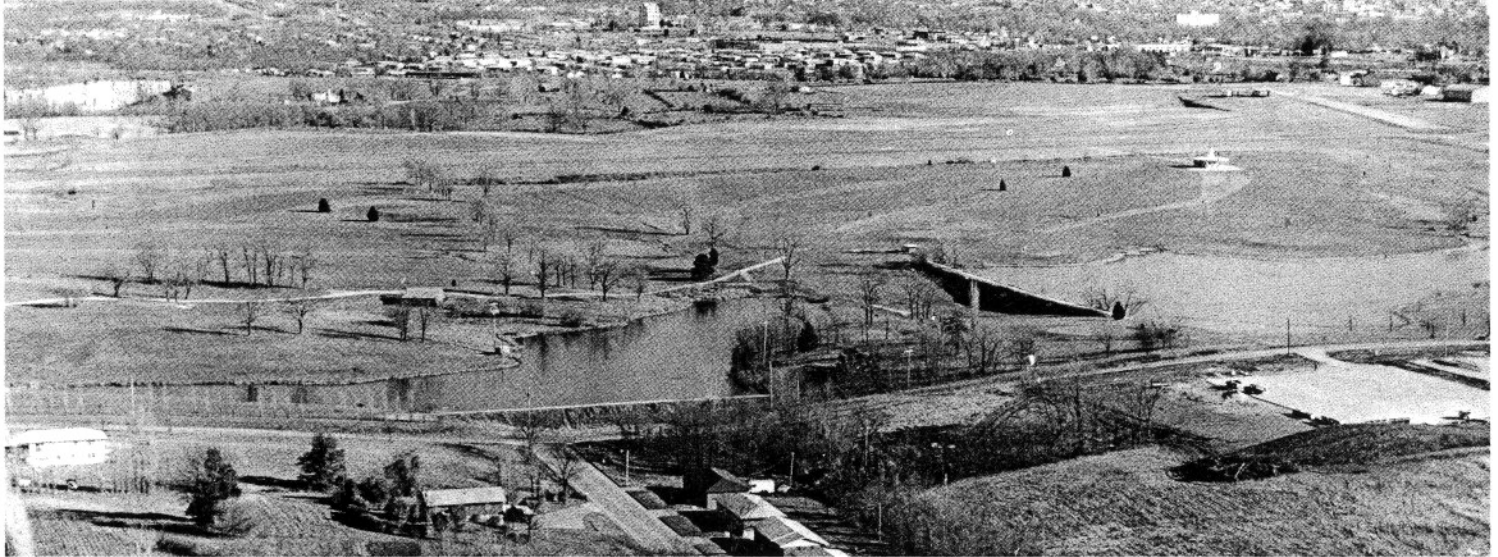
Figure 4

Construction of a low dam creates a large lake in relatively flat areas with low relief topography. Photo by David Rath.

Lakes in the upper watersheds of the Ozarks tend to be small (fig. 4) because

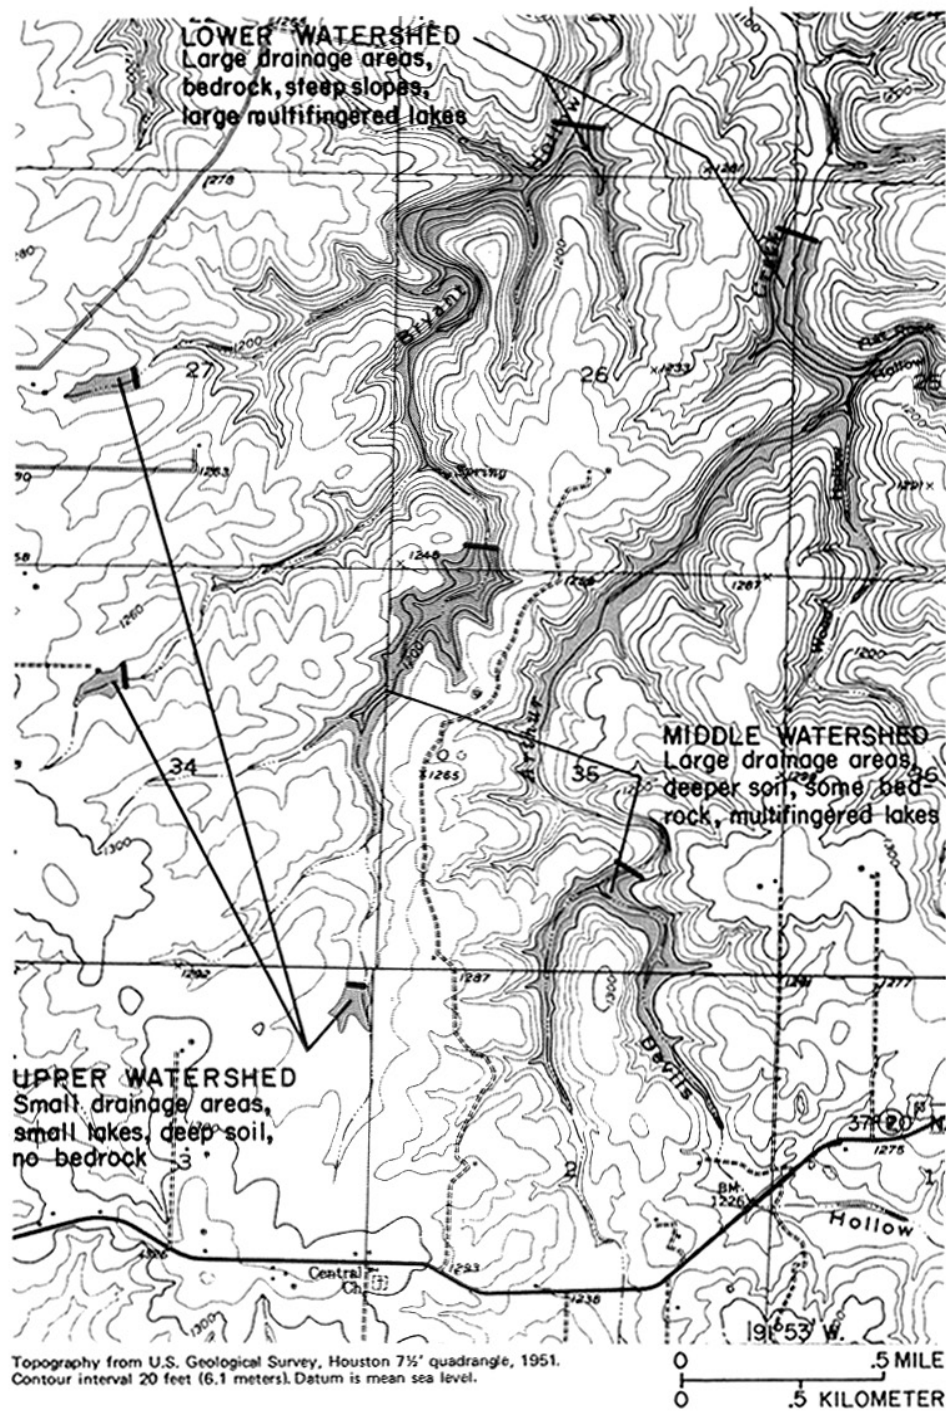
Figure 6

Topographic map showing hypothetical upper, middle, and lower watershed lakes in the Ozark carbonate area.

Topographic conditions suitable for construction of lakes exist in all parts of the Ozark watersheds, as shown in figure 6. There are, however, marked differences in the features to be found in the upper, middle and lower watersheds.

A comparison of figure 7 with figure 6 shows that much wider lakes are created in the upper watersheds of the western plains than in the Ozark carbonate area because the valleys are wider, requiring longer dams. The lakes are short due to steep stream gradients; thus, lakes in this area are often as wide as they are long.

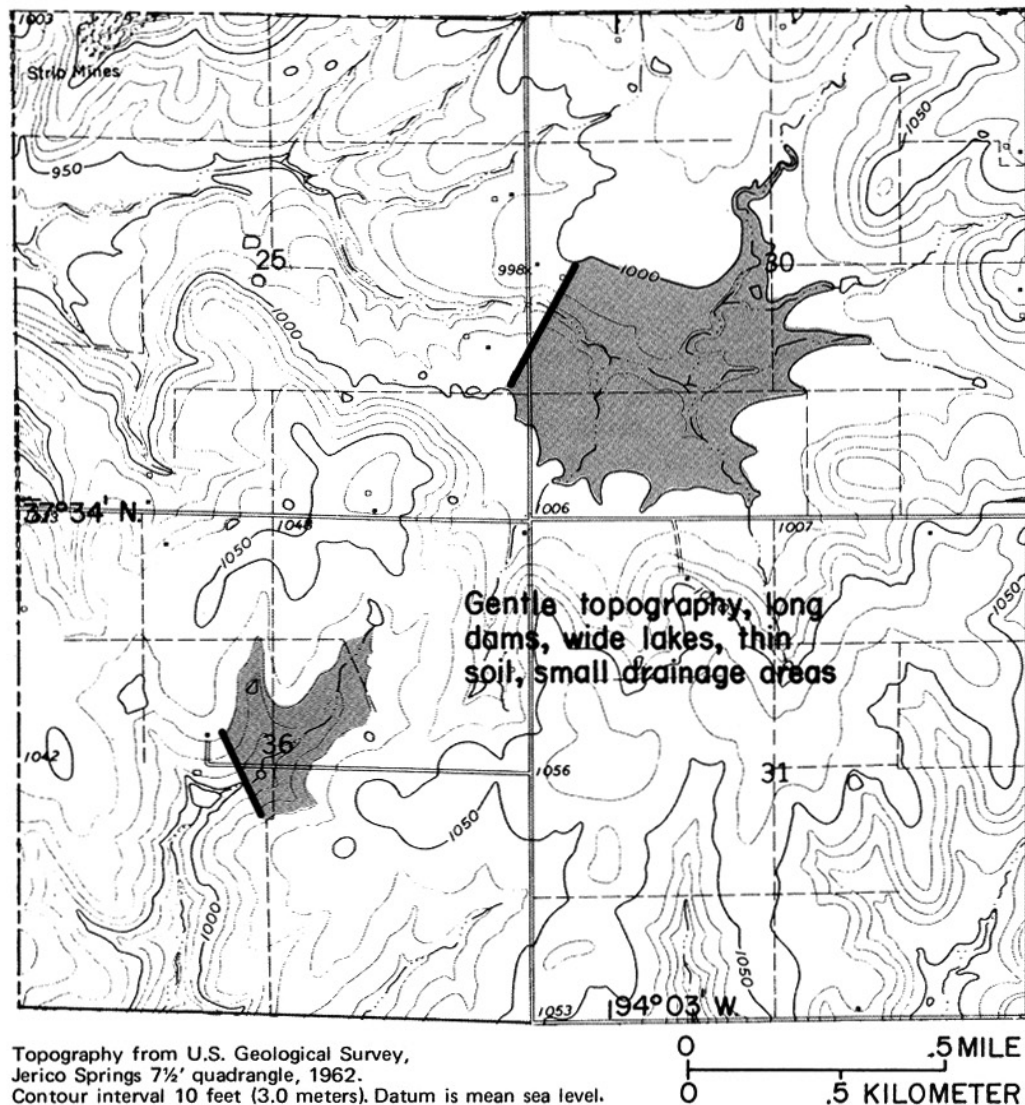
Figure 7

Topographic map showing hypothetical upper watershed lakes in the Western Plains. Lower watershed lakes (not shown) are like those in figure 2.

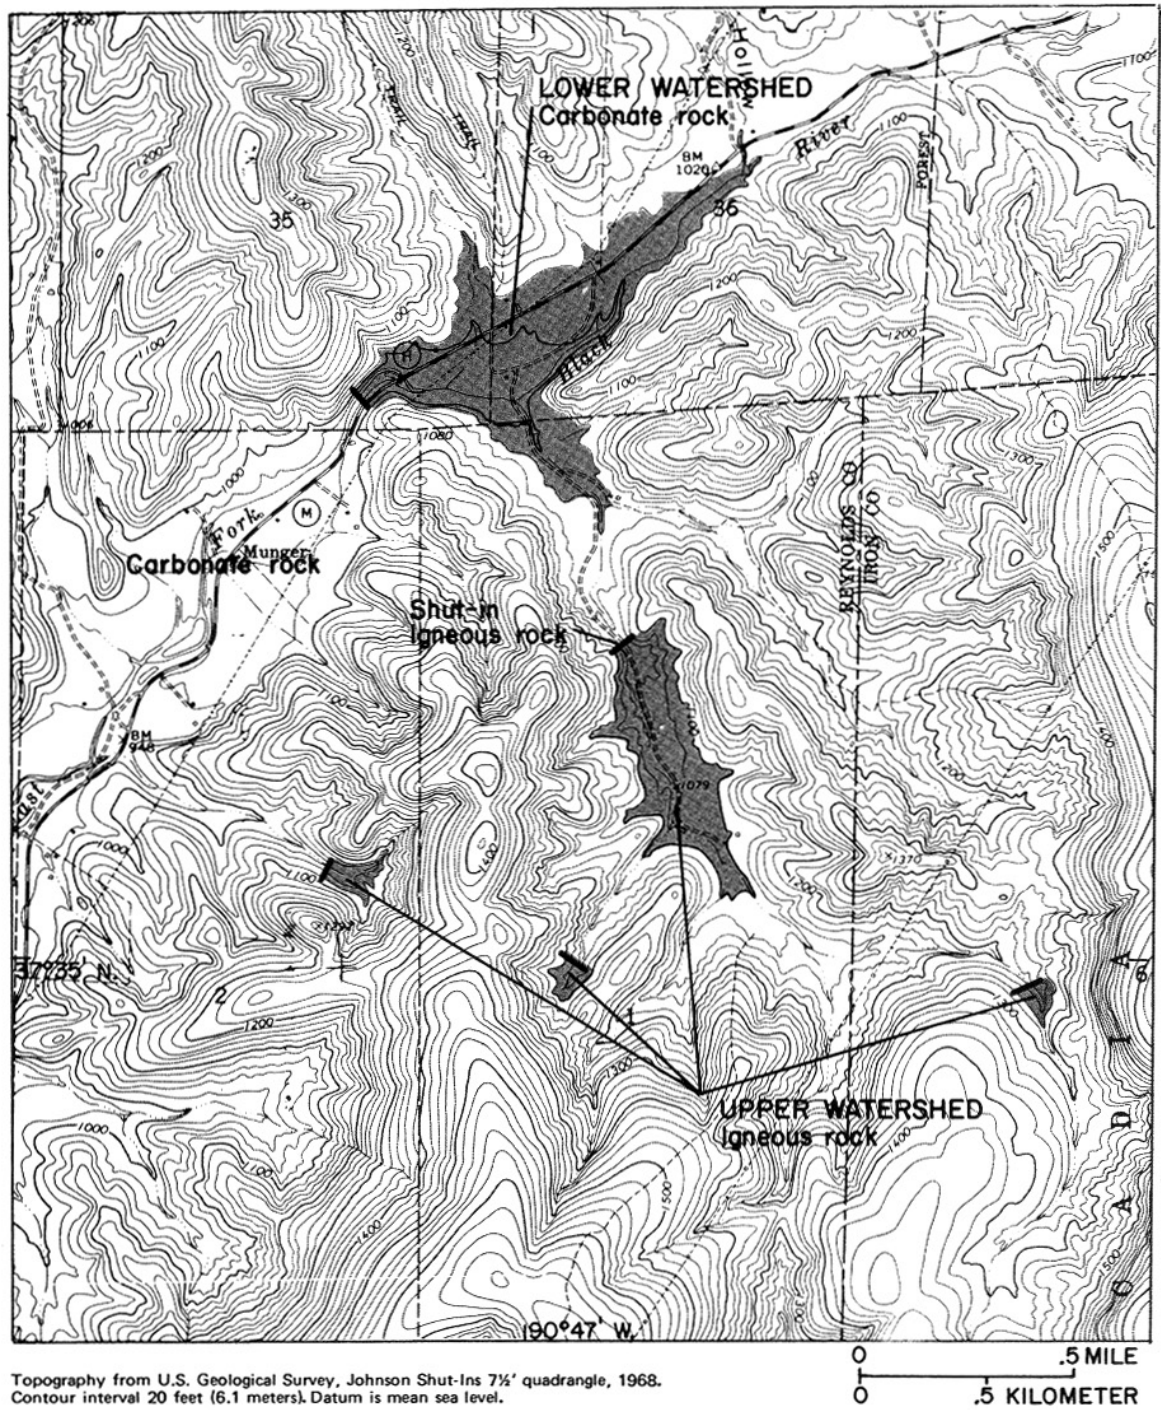
Figure 8

Topographic map showing hypothetical upper and lower watershed lakes in the St. Francois Mountains.

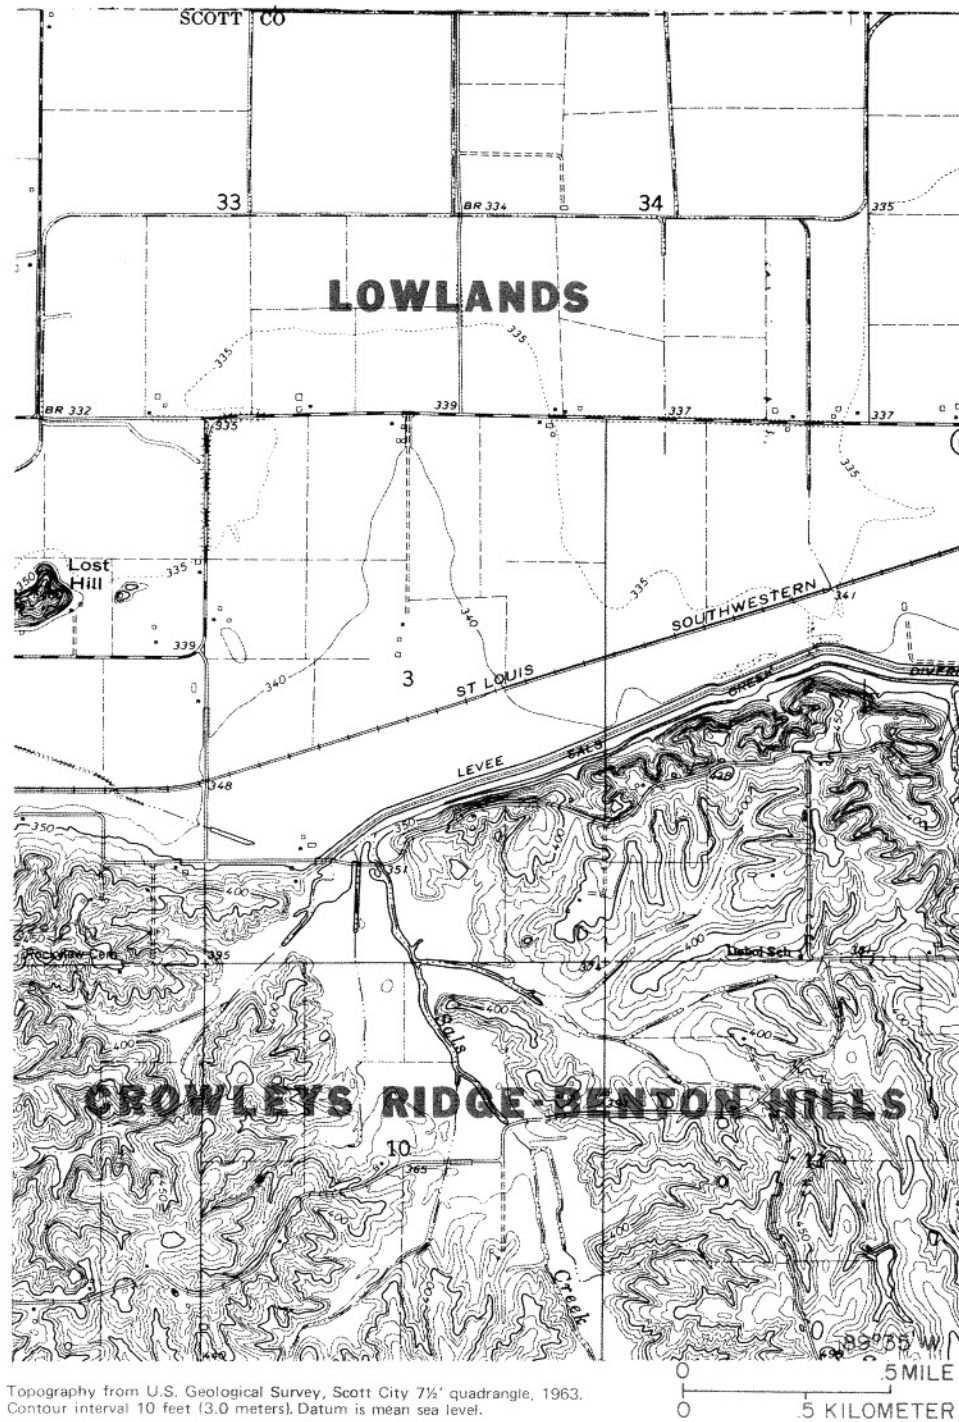
Figure 9

Topographic map showing the contrast in relief between the alluvial plains of the lowlands and the hilly topography of Crowleys Ridge-Benton Hills in the Southeastern Lowlands.

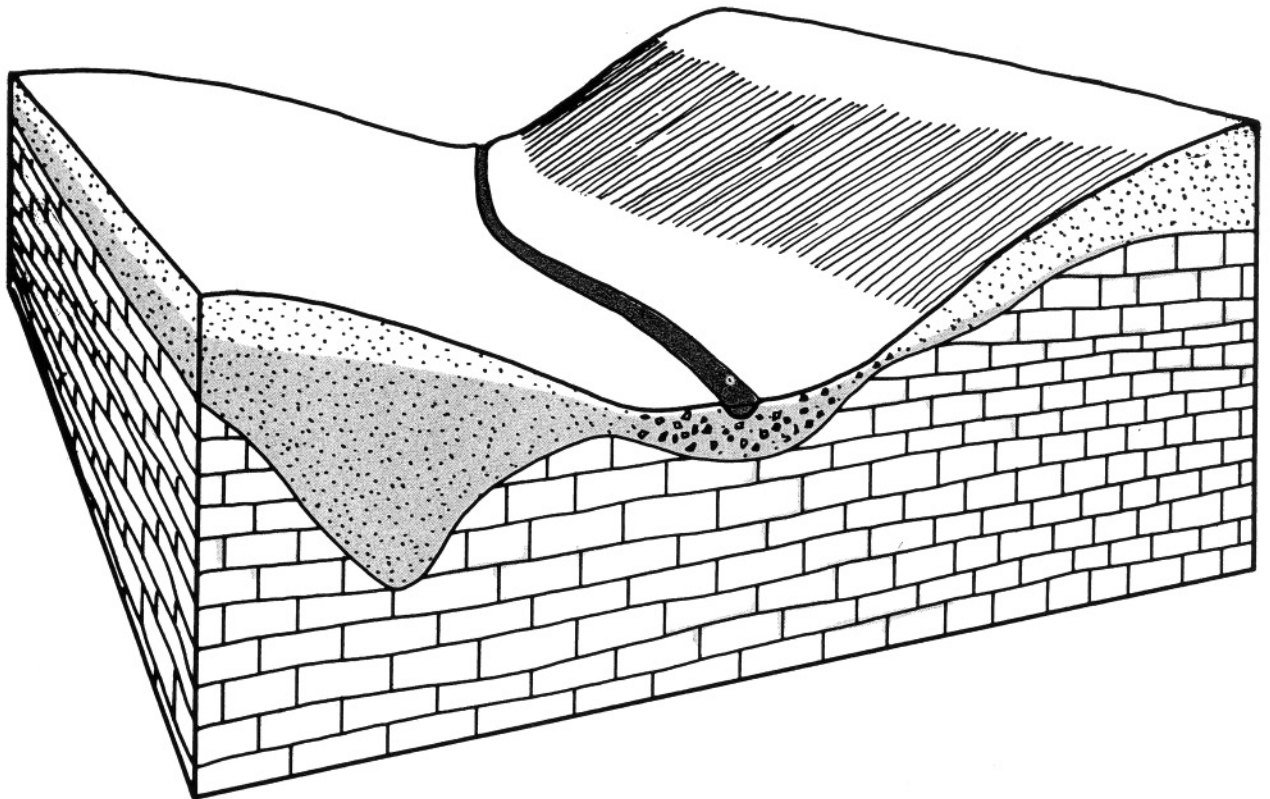
Figure 10

Schematic diagram of a valley cross section showing uneven bedrock surface.

Exploration of the valley bottom to determine shallow subsurface conditions that cannot be prejudged from surface evidence (fig. 10) can often be done inexpensively with a tractor-mounted backhoe. Several holes can be excavated on the center line of the proposed dam to determine depth to bedrock, quality of material over bedrock, the presence of water, and estimate the cost of the core. Backhoe test pits can also be used to evaluate

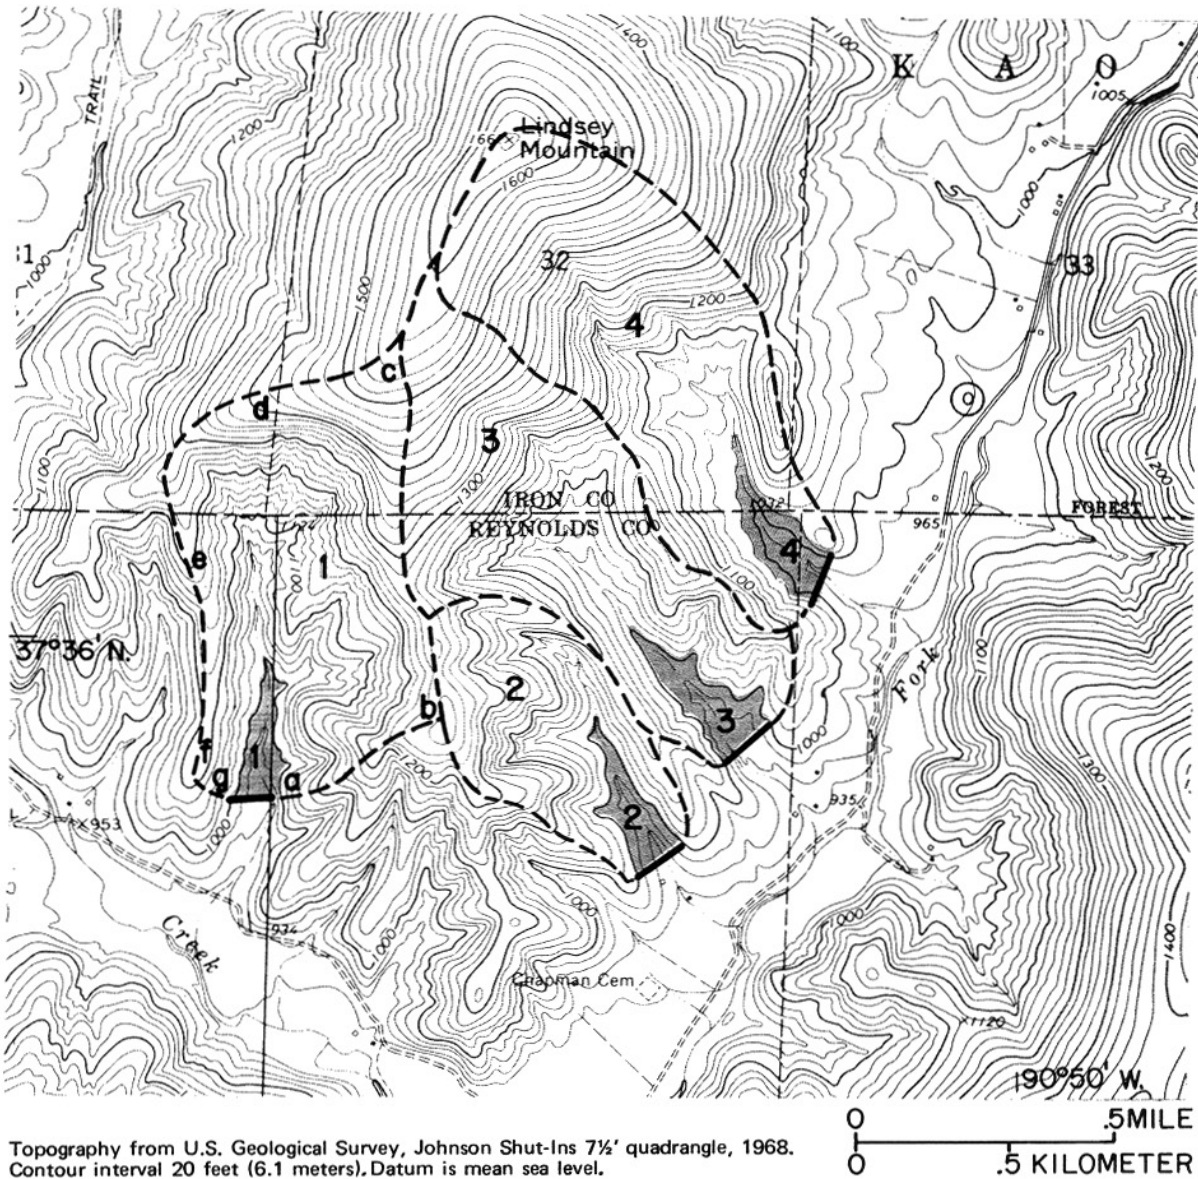
Figure 12

Computing drainage areas on topographic maps. (Numbers 1, 2, 3, and 4 represent small lakes and their corresponding drainage areas.) To draw the drainage area for lake no. 1, start at the dam at point (a), go up the valley wall to the right to the ridgetop at point (b), then go up the ridge line to point (c), follow the ridge to the left through points (d, e, and f), then drop down the valley wall to point (g), the other end of the dam. You have followed the ridge line around the lake and have outlined the drainage area. Follow the same procedure for lakes 2, 3, and 4.

On this scale map, a grid pattern of squares 5/16 inch (7.9 mm) on each side divides the area into 10-acre plots. Drainage area no. 1 has approximately 23 squares or 230 acres of drainage; no. 2, 110 acres; no. 3, 210 acres; no. 4, 220 acres.

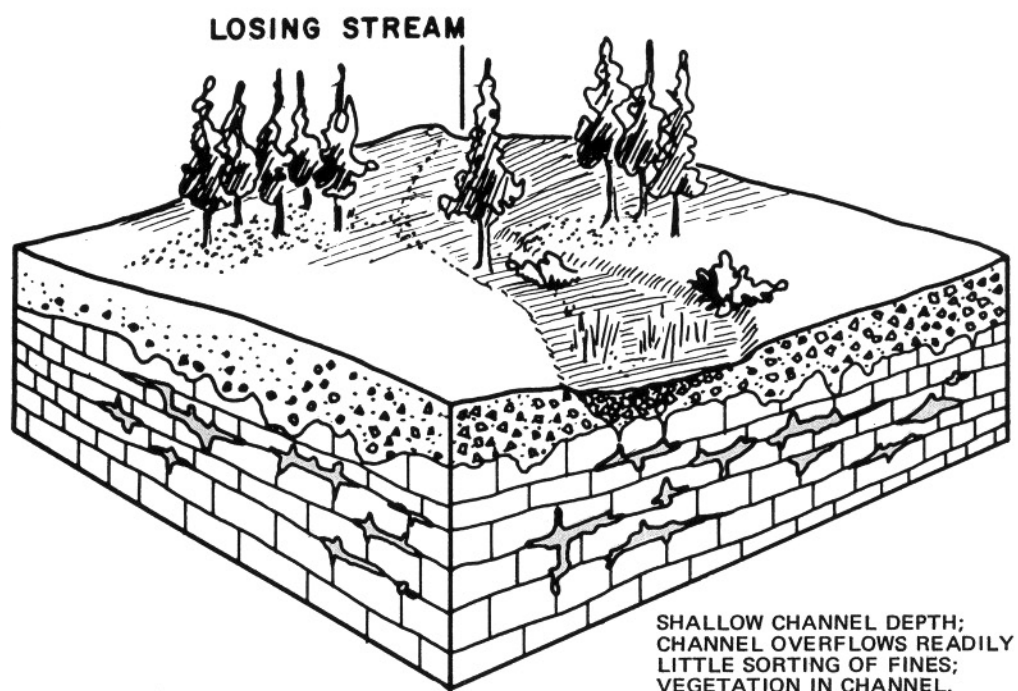
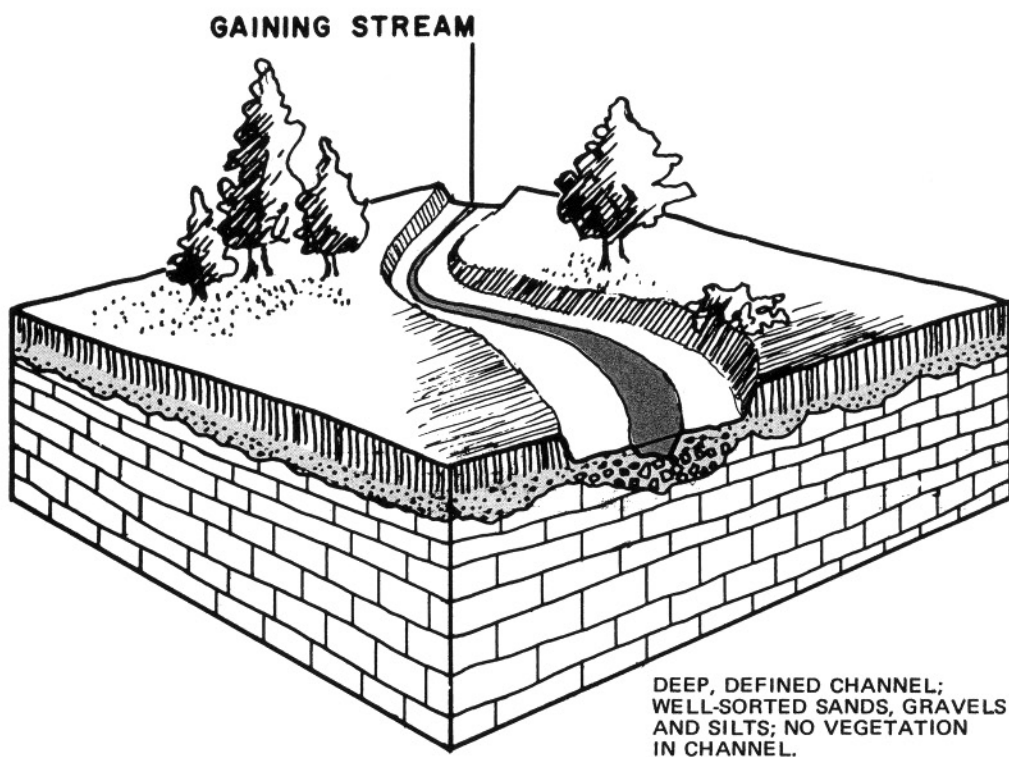
Figure 13

Schematic diagrams of valley cross sections showing a poorly defined channel (losing stream) and a well defined channel (gaining stream).

A continuous flow of water is usually indicative of a relatively impermeable valley (lake) bottom. As shown in figure 13, absence of vegetation in the channel, well sorted or stratified sands and gravels, clay-rich soil zones, and terraces are indicators of a gaining reach of the stream even though the stream may be dry at the time of investigation due to climatic conditions or small drainage area. Many

Generally, a dry, poorly defined stream channel, as shown in figure 13, is

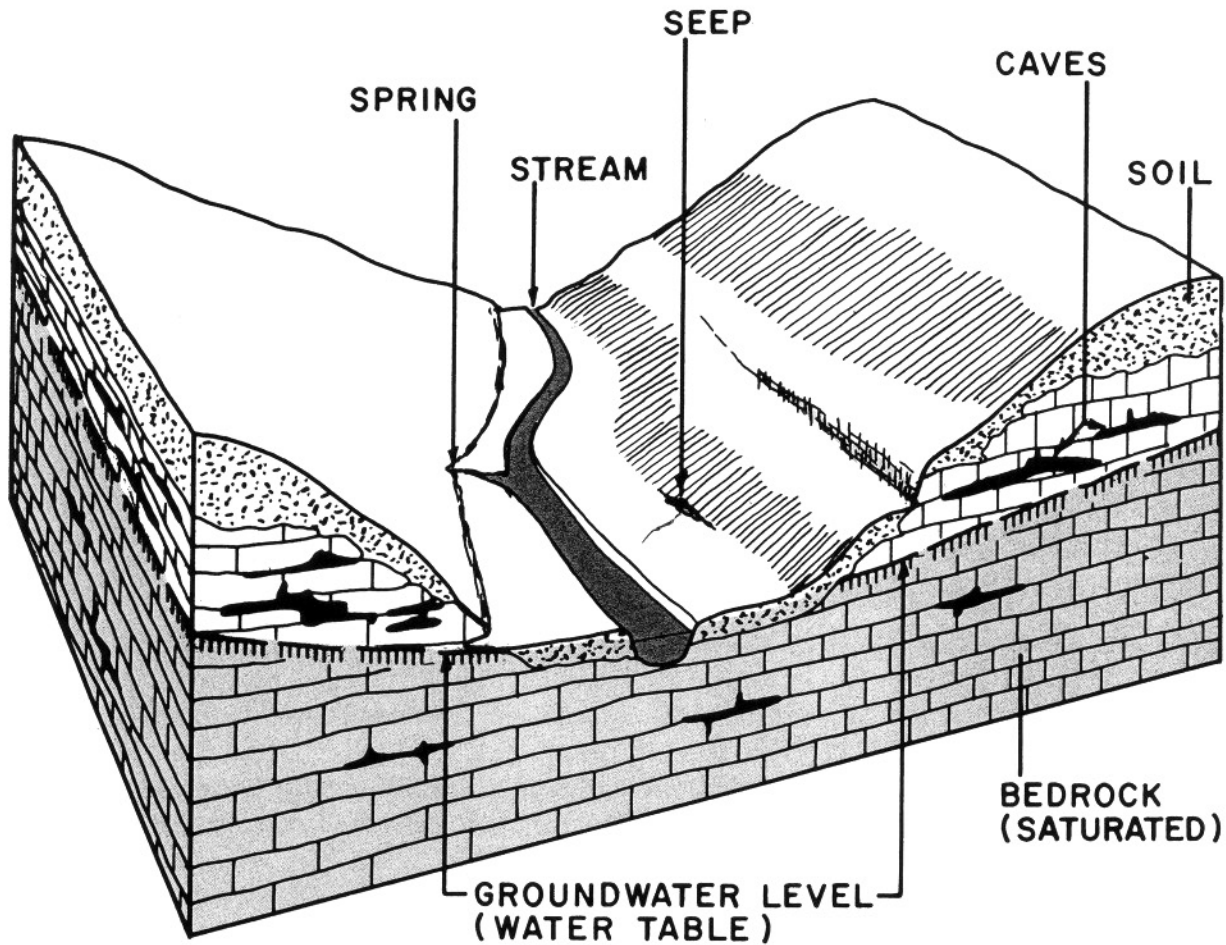
Figure 14

Schematic diagram of a valley which intersects the groundwater level.

Springs, seeps and perennial flow are evidence of a high water table level in many cases. A water table that is high enough to be intersected by a valley is likely to cause a perennial flow into the stream as shown in figure 14. Springs and seeps are ground water being discharged at the surface. Perennial flow caused by high water-table level does not always indicate impermeable bedrock in the valley bottom.

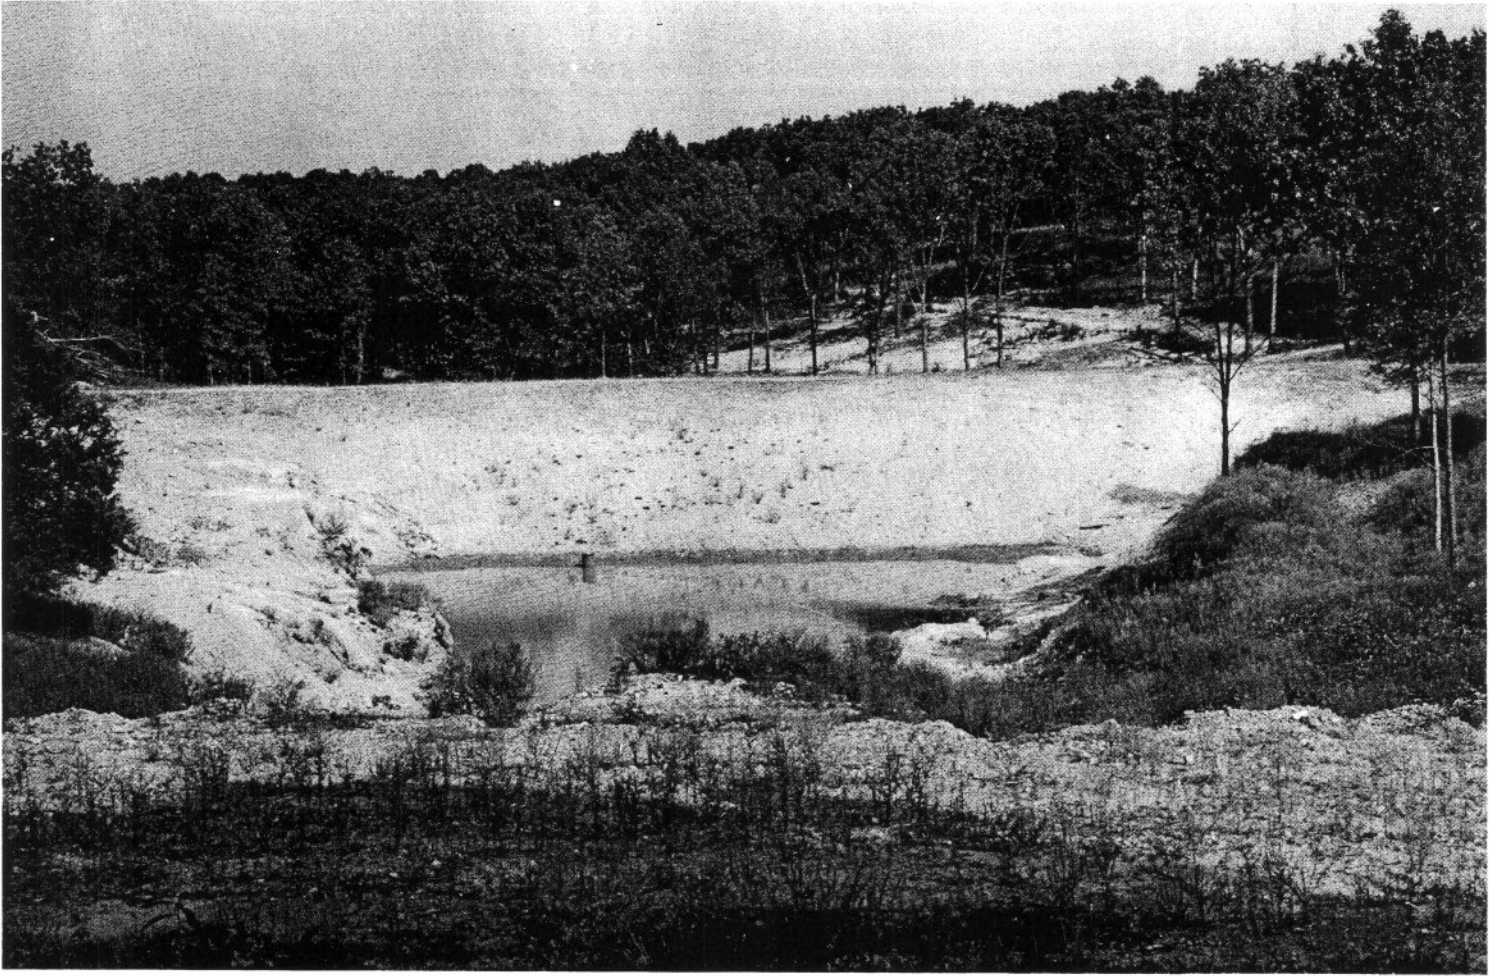
Figure 15

This obviously unsuccessful lake should never have been constructed in this location because of adverse geologic conditions. It would be uneconomical to repair. Photo by David Hoffman.

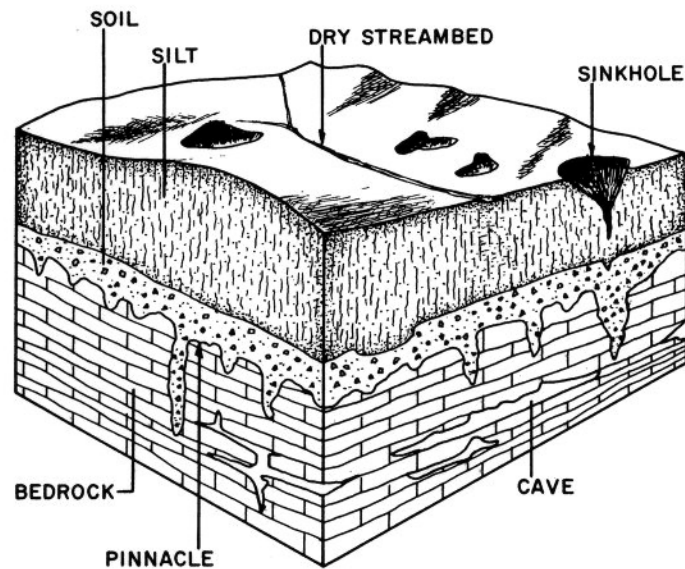
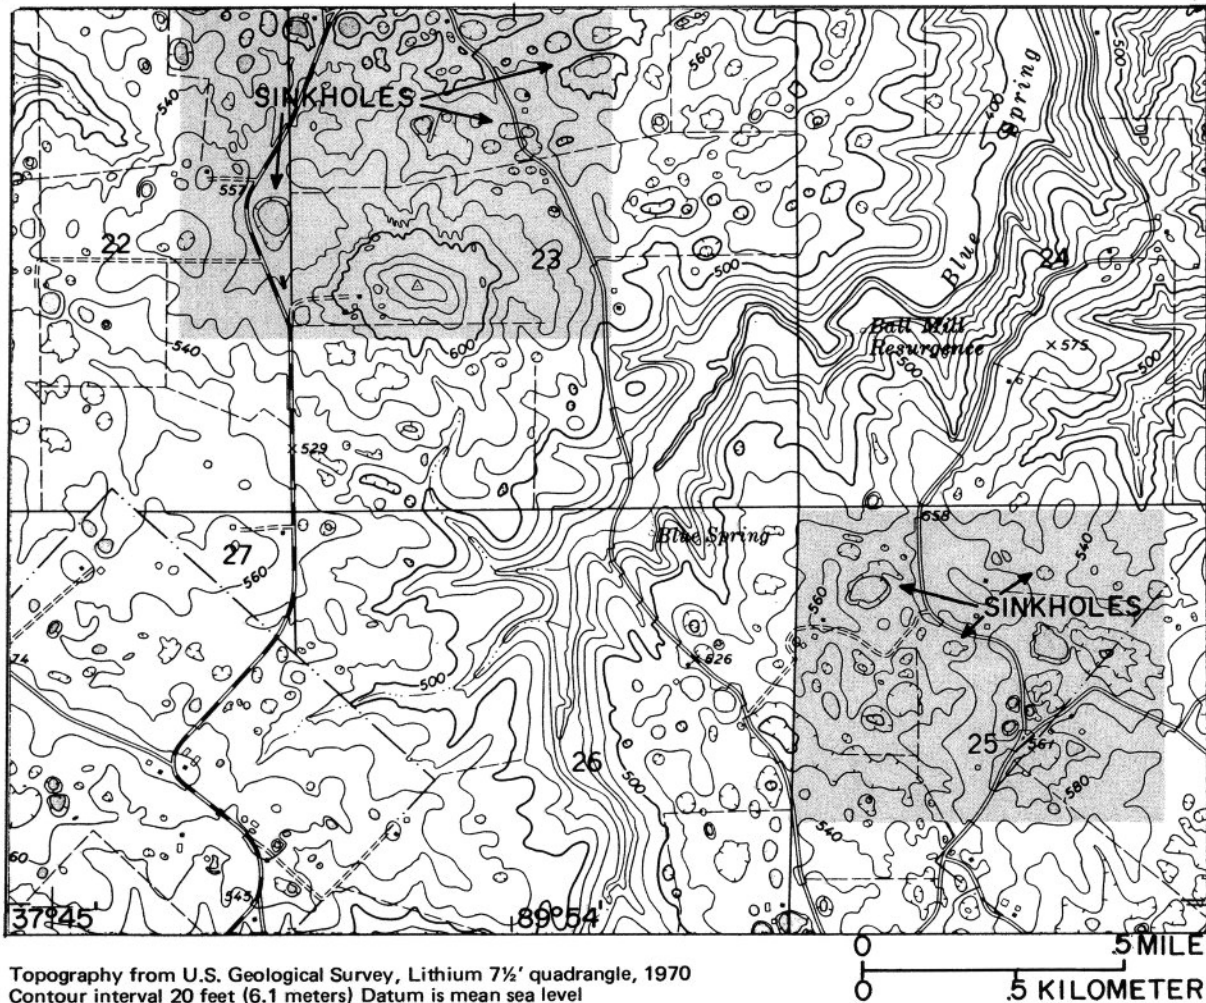
Figure 16

Schematic diagram showing karst features (including sinkholes) and solution work in joints and bedding planes. The topographic map shows karst features.

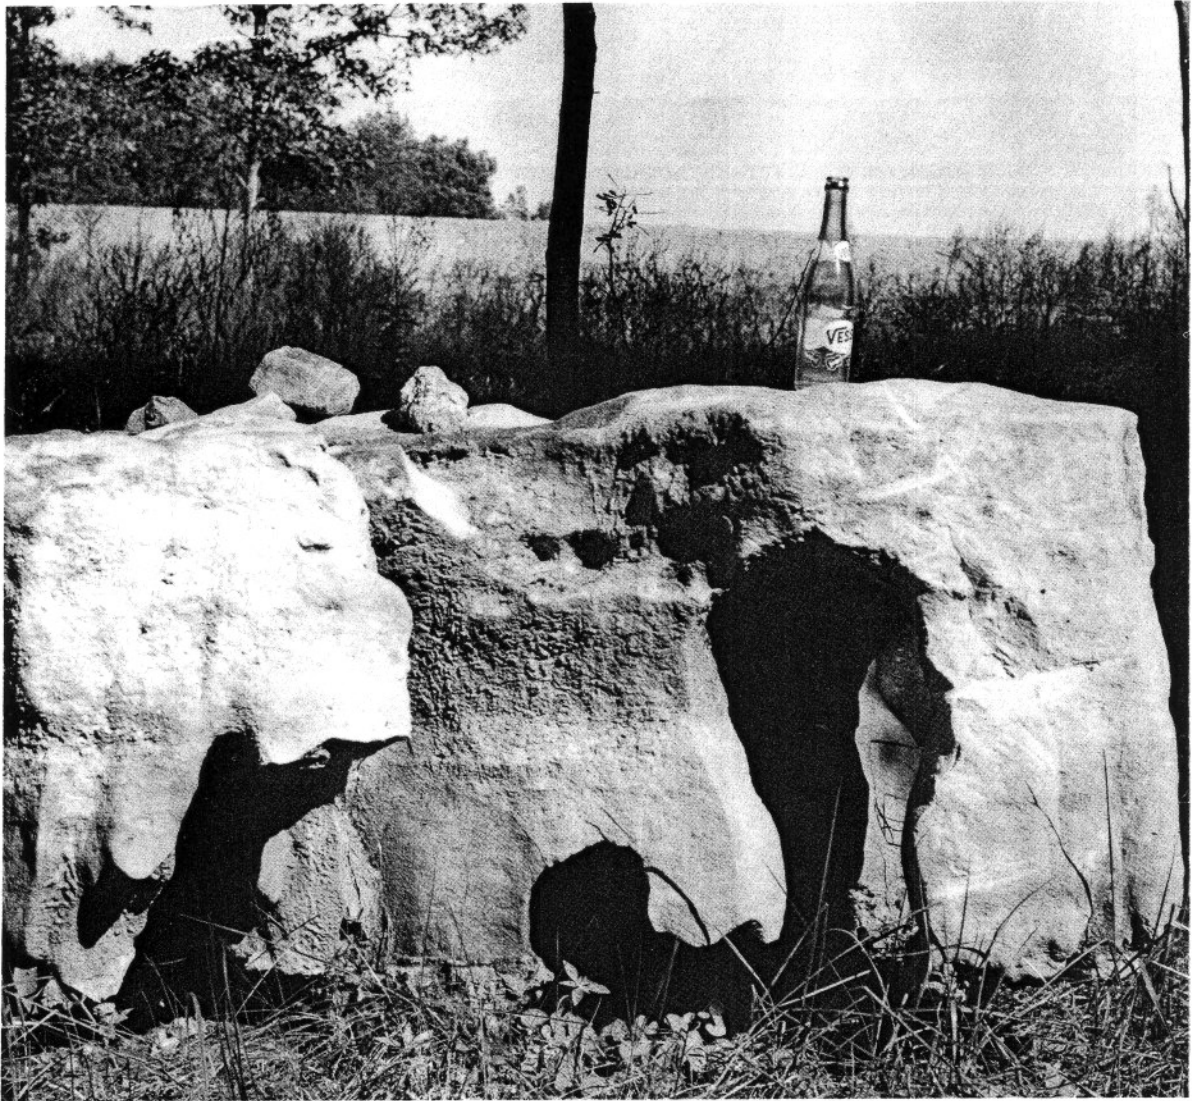
Figure 17

Solution work caused by running water makes for a permeable lake bottom. Photo by Jerry D. Vineyard.

Pinnacles (spire-shaped pillars of rock) are formed by solution along joints or cracks in the bedrock, or by differential weathering caused by abnormalities present in the rock. This phenomenon is not too unlike the sinkhole-cave relationship. The space between the pinnacles is not expressed on the surface as a depression, but rather as a filled depression (fig. 16). Thus, there may be no surface evidence of the problem. Bedrock may be present at the surface at one point, but 20 to 30 feet (6 to 9 m) away the soil may be many feet thick. The thick soil filling the crevice between the pinnacles is usually very permeable and may result in serious water loss from the lake (fig. 17).
